Order No. 104633529

Date: April 30, 2021

REPORT NO. 104633529CRT-001a**ACCUMULATION OF MOISTURE
ON DIFFUSER SURFACE TEST
ON TWO DIFFUSERS****RENDERED TO****INVI USA, LLC
67 GUERNSEY STREET
BROOKLYN, NY 11222****INTRODUCTION**

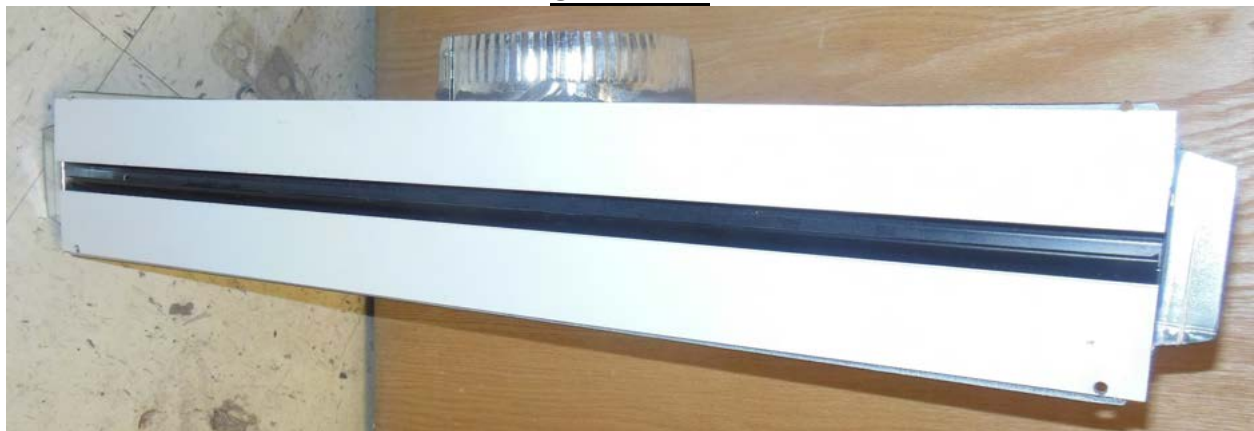
SAMPLE 1

The first sample consisted of a single slot diffuser with a $\frac{3}{4}$ inch by 25 inch slot installed in a 3 inch by 25 inch by 9 inch lined plenum box with a 6 inch diameter inlet. The sample was constructed from aluminum. The second sample consisted of a single slot diffuser with a $\frac{3}{4}$ inch by 25 inch slot installed in a 4 $\frac{1}{2}$ inch by 26 $\frac{1}{2}$ inch by 9 inch lined plenum box with a 6 inch diameter inlet. The sample was constructed from a composite material.

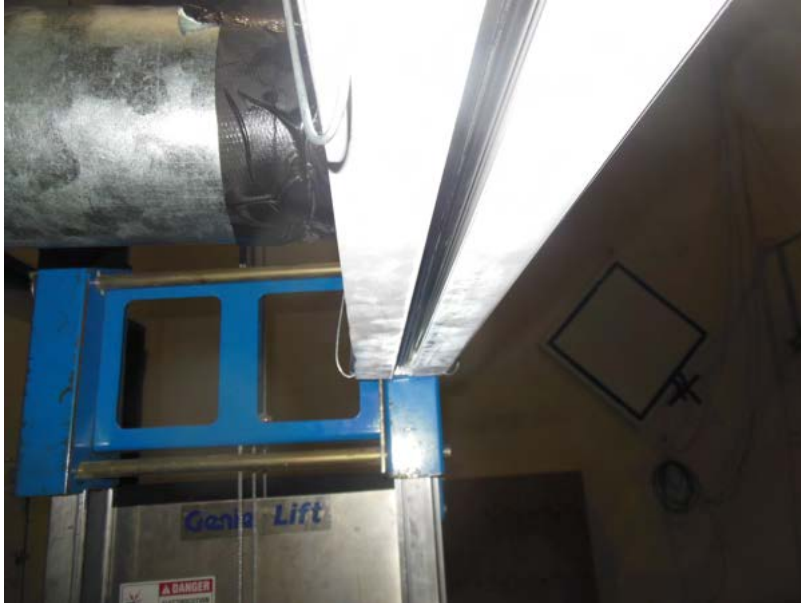
PHOTO AFTER 2 MINUTES OF AIR BEING SUPPLIED

Note: The sample had noticeable moisture content on the surface after 2 minutes and large water droplets after 20 minutes of operation.

Inlet Air Temperature and Relative Humidity: 56 Degrees Fahrenheit and 35% RH

Room Temperature and Relative Humidity: 85 Degrees Fahrenheit and 60% RH

Inlet Airflow: 100 CFM

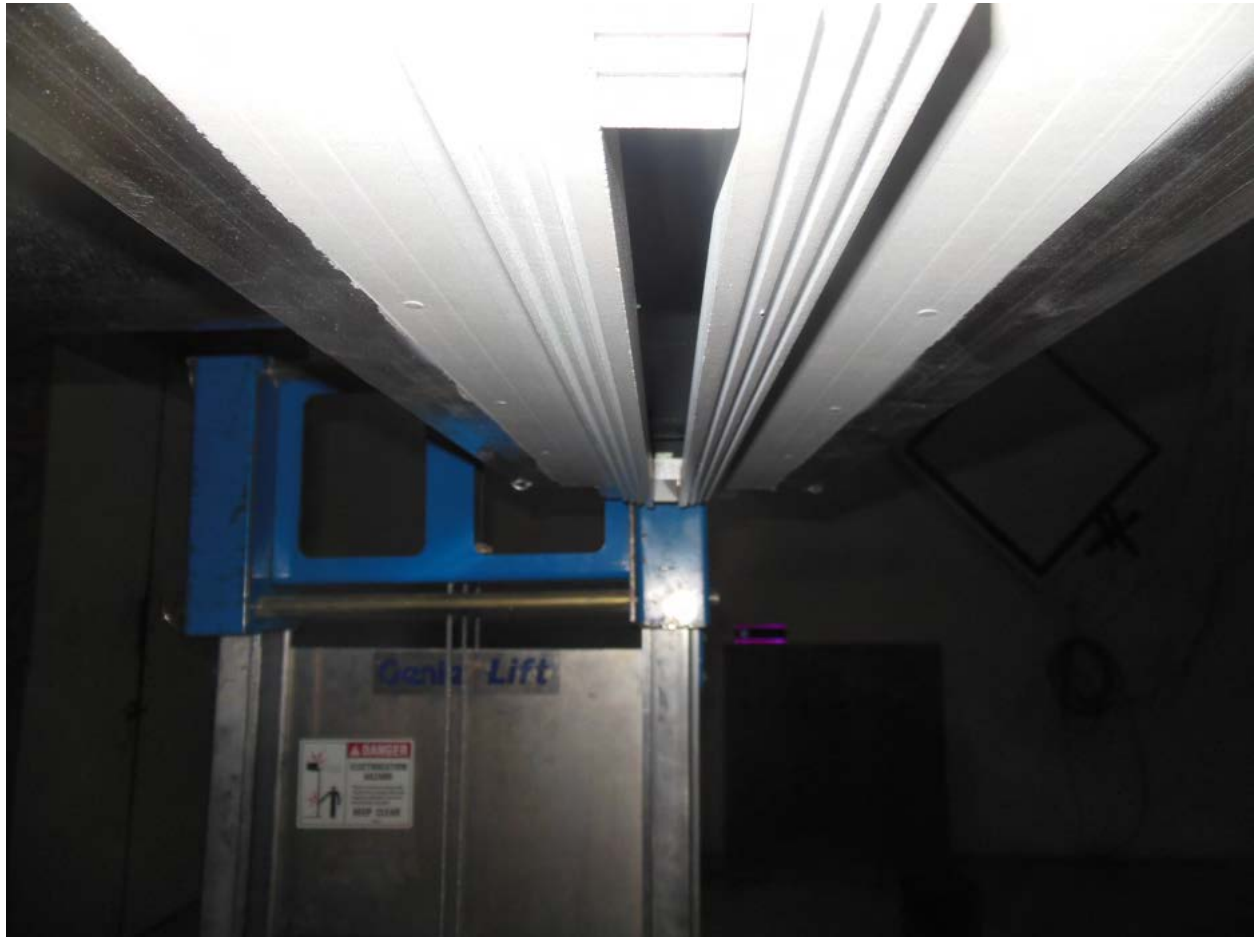
PHOTO AFTER 20 MINUTES OF AIR BEING SUPPLIED

Note: The sample had no visible moisture content on the surface after 2 minutes and no visible moisture content after 20 minutes of operation. No significant changes were observed for 60 minutes.

Inlet Air Temperature and Relative Humidity: 56 Degrees Fahrenheit and 35% RH

Room Temperature and Relative Humidity: 85 Degrees Fahrenheit and 60% RH

Inlet Airflow: 100 CFM
